DOUGLAS AIRCRAFT CO LONG BEACH CA

FLIGHT TEST EVALUATION OF AIRBORNE TIRE PRESSURE INDICATING SYS--ETC(U)

SEP 79 R R SUITER, W W KWONG

FAA-RD-78-134-2

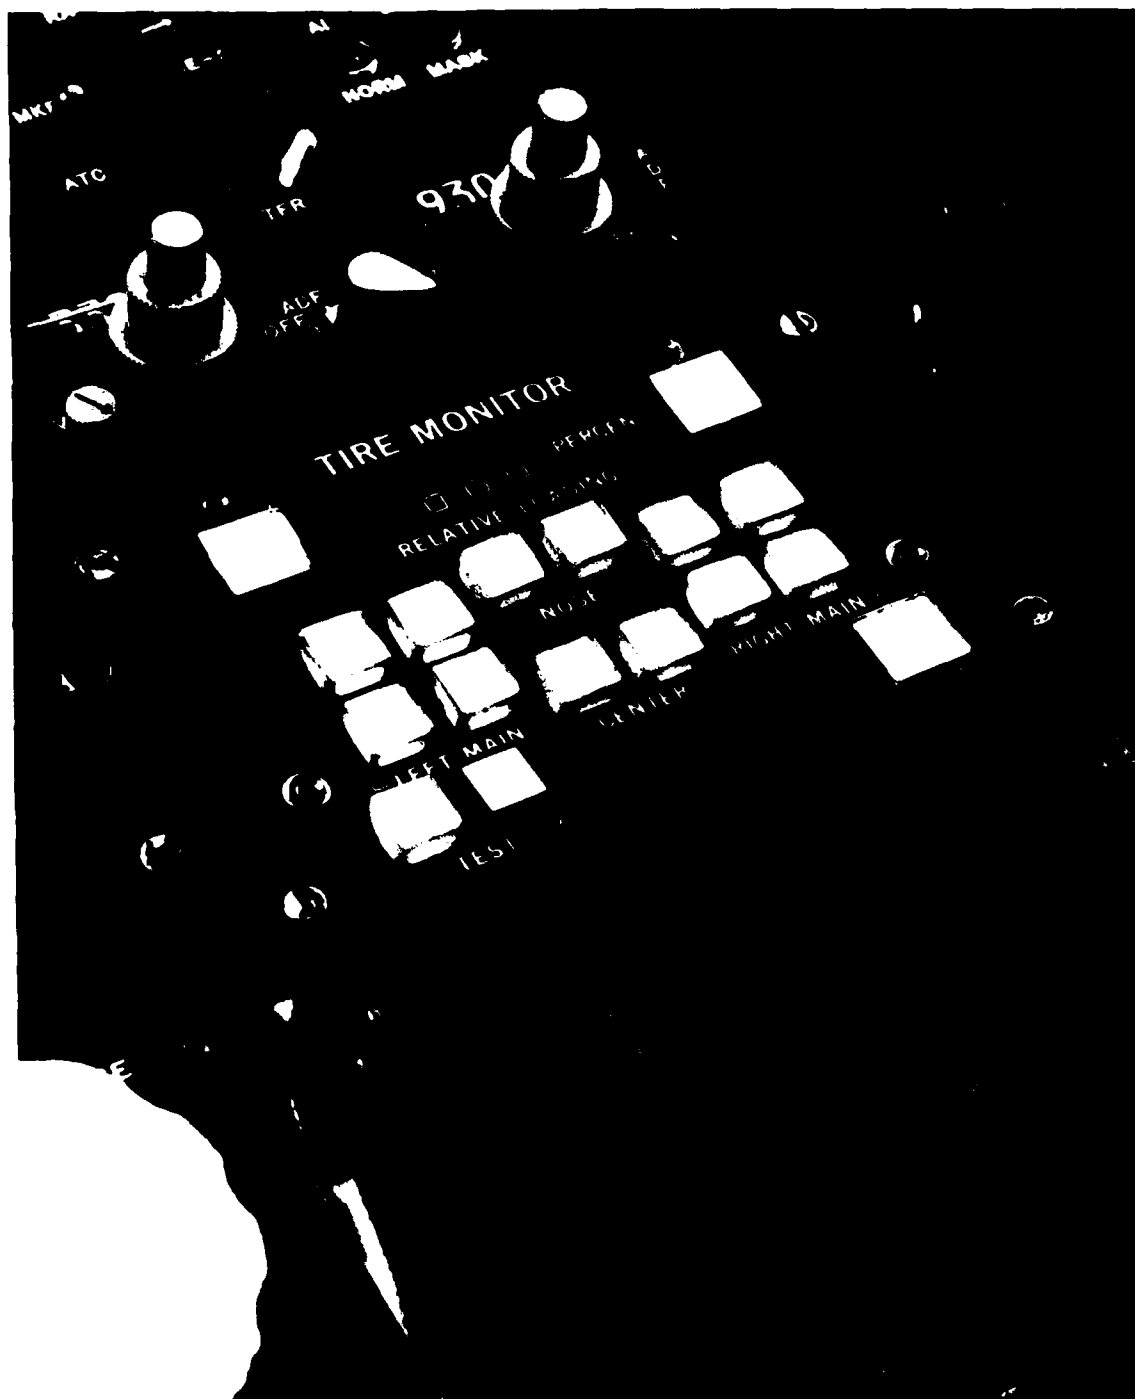
FIGURE 17. COCKPIT-MOUNTED DISPLAY PANEL

1. Press the switch button on the cockpit display associated with the tire load reading wanted.
2. The switch button will illuminate when activated and the digital display will come on indicating the relative loading on that tire.

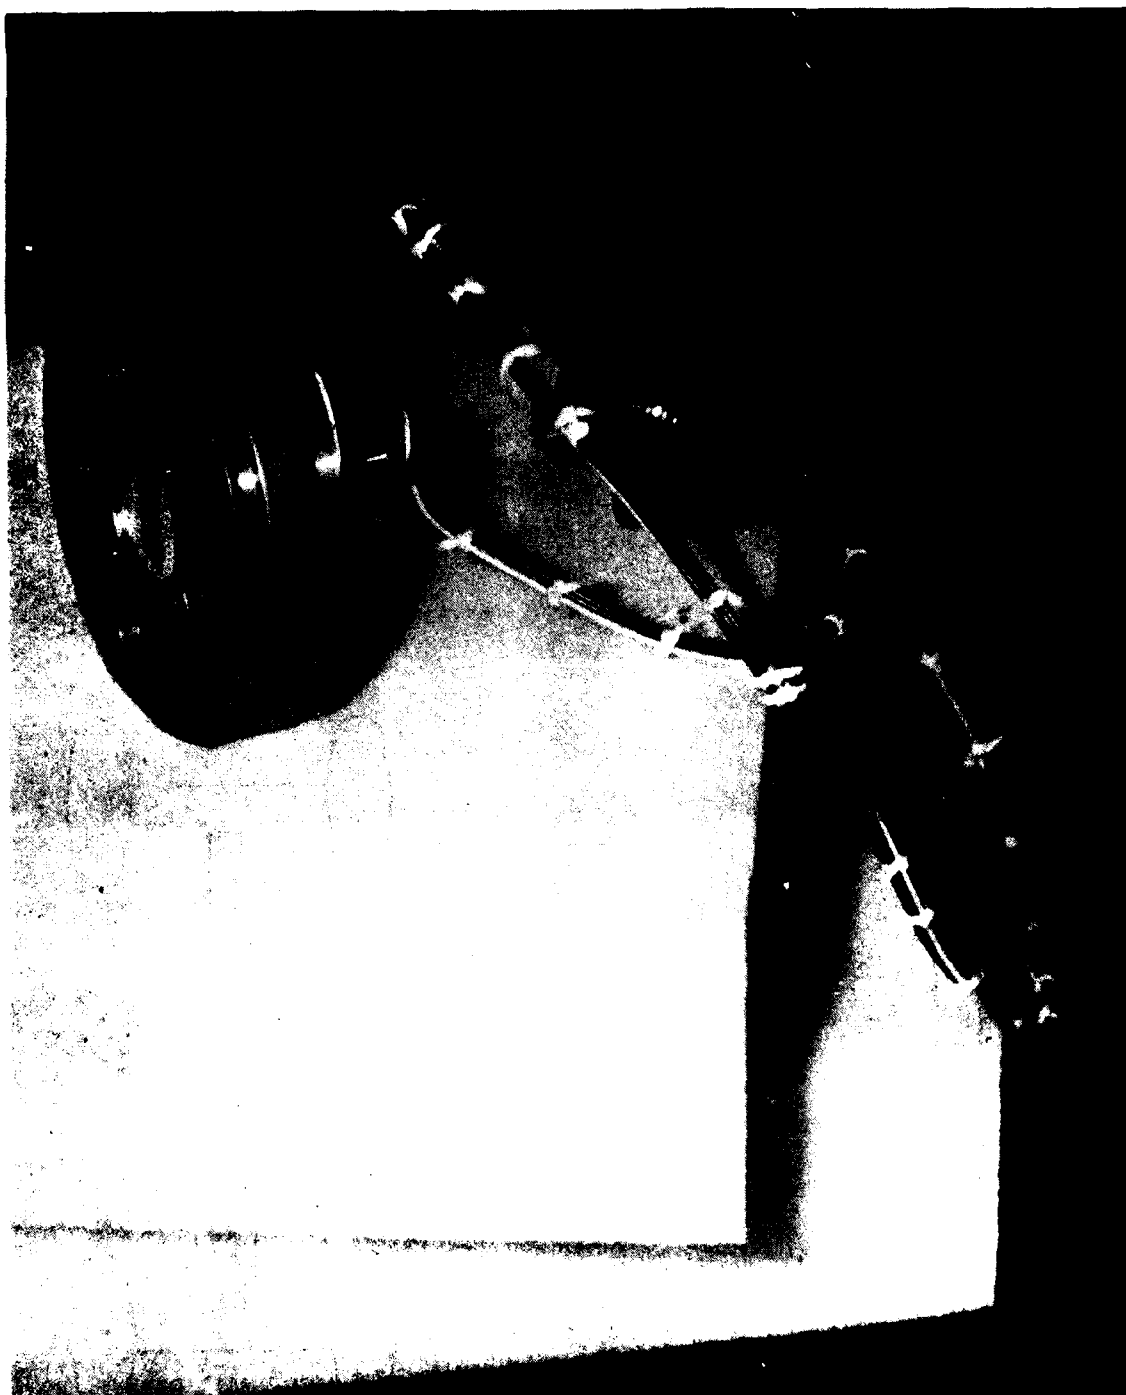
FIGURE 31. NOSE WHEEL SENSOR AND MOUNT

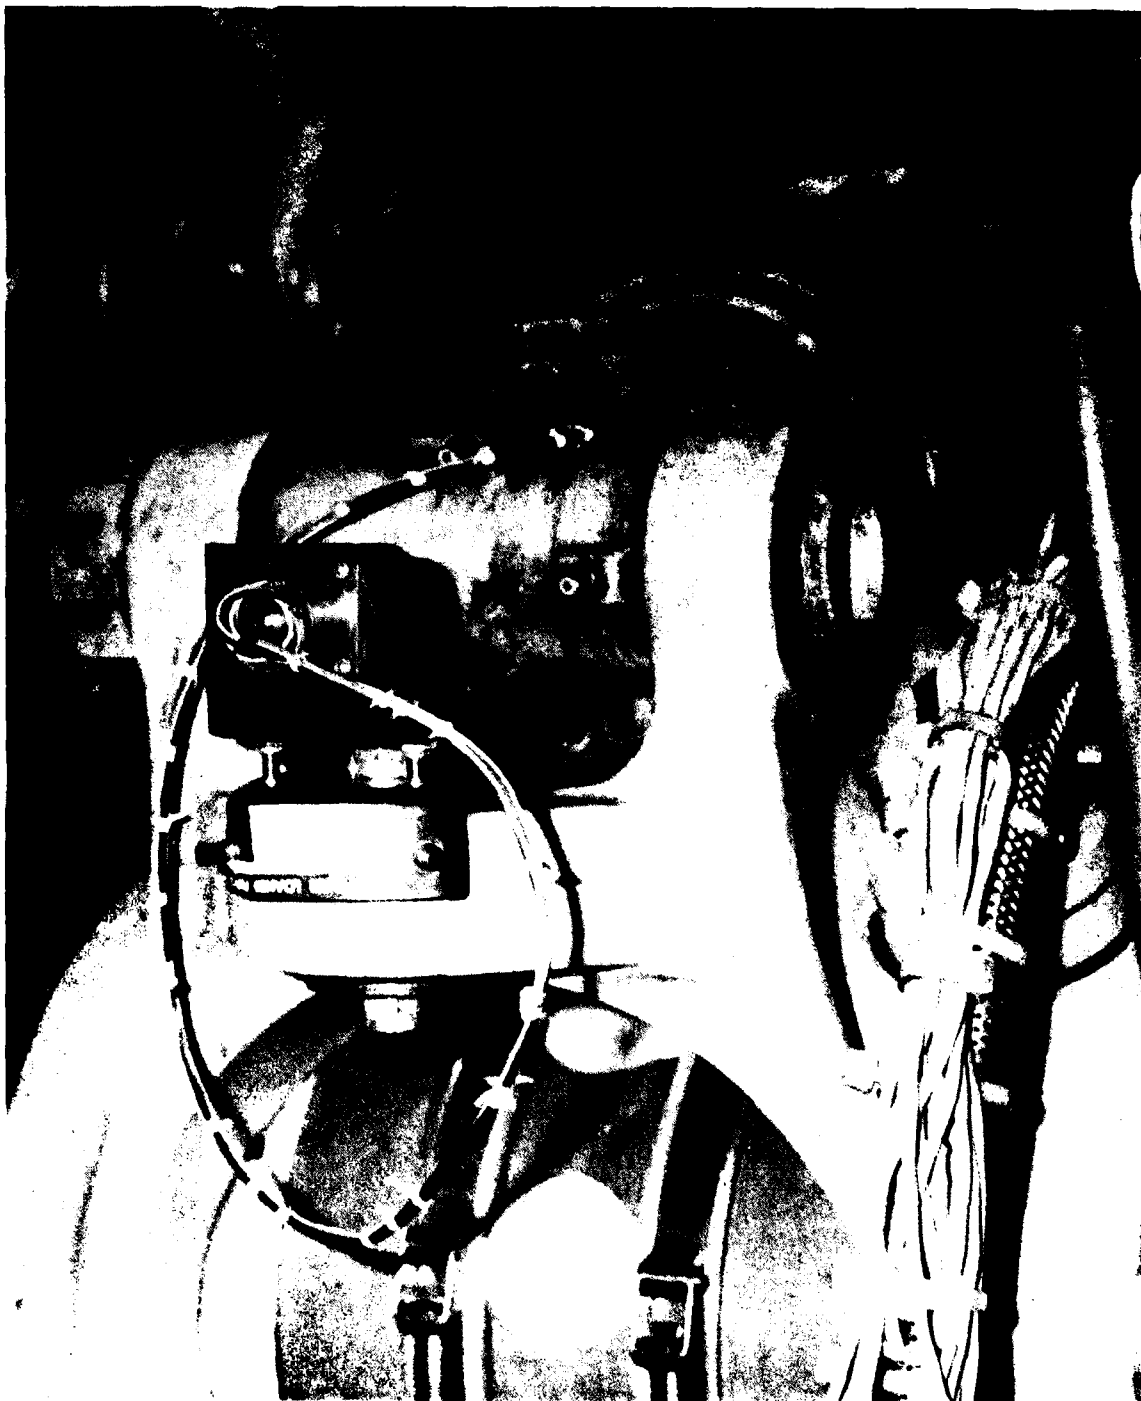
FIGURE 32. FORWARD BOGIE BEAM MOUNT AND SENSOR
